RECONSTRUCTION OF THE FIRE IN “DE HEMEL” IN VOLENDAM, NEW YEARS EVE 2000/2001

S. M. Öhlin Lostetter and P.B. Reijman, TNO Centre for Fire Research, The Netherlands &
P.H.E. van de Leur, DGMR Consulting Engineers, The Netherlands

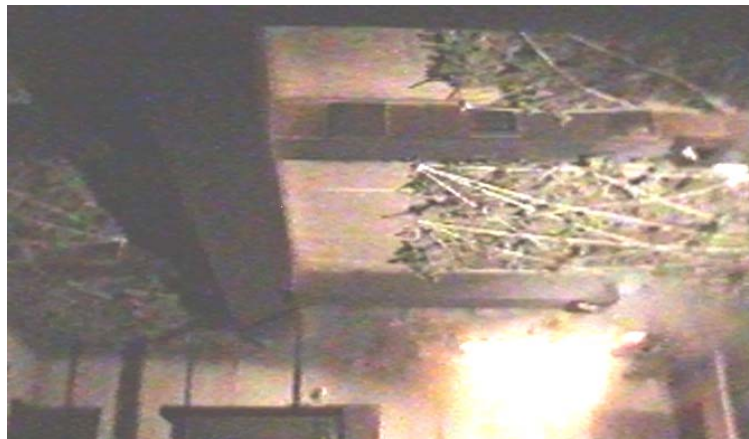
The fir branches ignited directly when the sparklers were put in contact with them. The fire stayed in the area where it had been ignited for about 40s and contrary to tests 1a and 1b, no branches fell down, due to the improved fixing of the Christmas lights. Instead, a “ball of fire” was visible between the branches and the roof. After 40s during a time period of 5s a number of branches started to fall down where the fire first was ignited. 5s afterwards the fire spread to the entire room. The time between the ignition of the branches and the fire spread to the entire room was 50s. The sight of the room after test 2 was very similar to the room after test 1b.

Picture 2: Room during first 40 seconds of fire, a ball of fire is visible between branches and roof

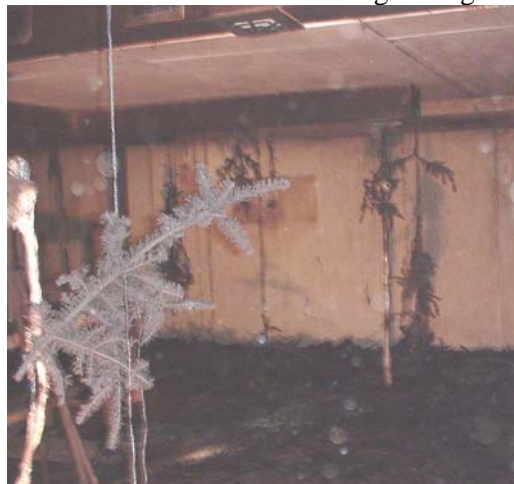
Picture 3: Room after extinguishing
